## River tragedy waiting to happen

Elko Daily Free Press, "Nature Notes", 6/2/2013

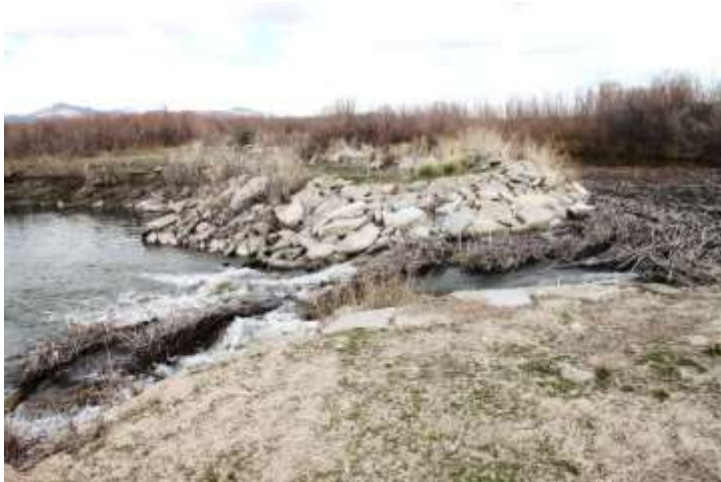
A diversion dam on the Humboldt River is containing a headcut

A tragedy is poised to occur on the Humboldt River. The above photo was taken upriver from Elko, close to Last Chance Road. The tragedy is evident in the above photo, but the problem is not the diversion dam, which is temporarily holding back the tragedy. It is also not the floating willow stems, apparently evidence of beaver activity upstream.

The problem shows in the difference in water levels above and below the dam. The water appears to drop about four feet as it tumbles over the boulders and concrete slabs flooring the dam.

Sherm Swanson is State Extension Range Specialist for the College of Agriculture, Biotechnology and Natural Resources at the University of Nevada, Reno. He told me this drop in water signals a headcut.

Such a headcut creates turbulence at the stream bottom, leaving behind a drop off like a small waterfall. This drop off moves upstream as swirling water erodes the bank forming the waterfall. It leaves behind an incised channel that concentrates water velocity and flood energy inside a gully. The headcut formed downstream from here, and it has moved upstream. At present, the diversion dam has temporarily stopped the headcut since the swirling water cannot easily erode through the boulders and slabs.

As the water falls over the dam, it has created a large, deep pool. One side of this pool is close to the river above the dam. As the pool widens, the bank separating it from the flowing river could erode, allowing the river to bypass the dam and free the headcut to again move upstream. It is very difficult to control a traveling headcut and very rare to have a chance such as this to stop it. The river bank and the dam bottom need to be maintained to keep this tragedy at bay and protect the upper Humboldt River.
